Section 19 Flood Investigation

Edinburgh Avenue - 26th August 2015 flood event

Slough Borough Council

January 2016 v1.0

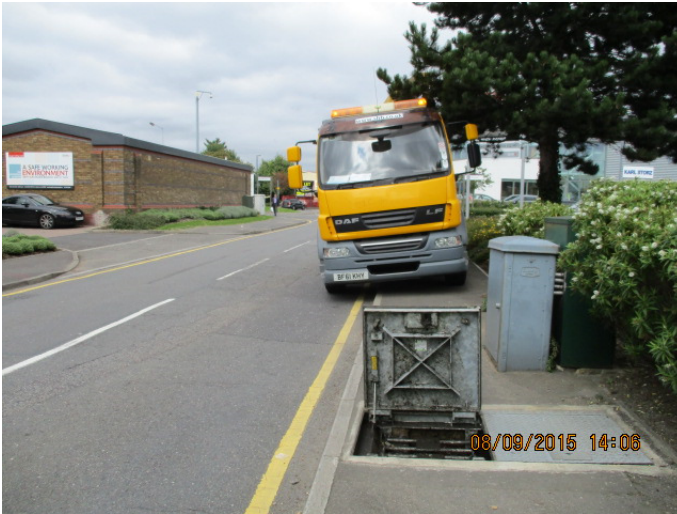
On September 8th 2015 Slough Borough Council visited Edinburgh Avenue to undertake a detailed inspection and found that the Thames Water pump station was not working. See photographs overleaf. If the Thames Water pump station had been operational the speed of inundation at Edinburgh Avenue would have been slower and the extent of flooding would have been less. It later transpired that Thames Water were not aware that the pump had failed² indicating that the alarm warning of pump failure does not work.

Figure 2-1 SBC visiting the Thames Water pump station

The pump is a critical asset and must be operational. Thames Water have since fixed the pump but the alarm must also be fixed to ensure that the pump remains operational.

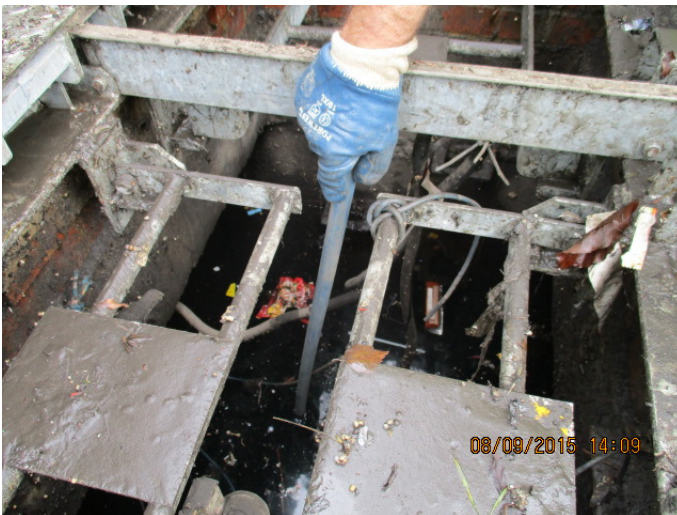
Figure 2-2 Pump station chamber full of water

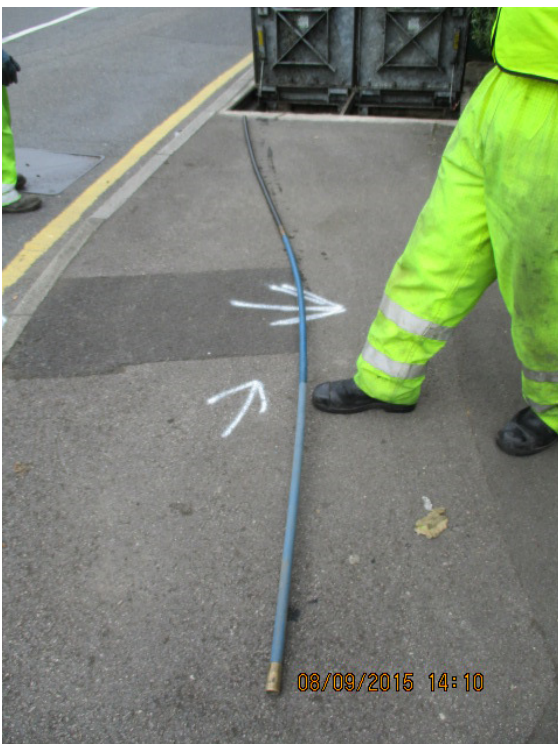
Figure 2-3 Rod dipped into the chamber to demonstrate depth

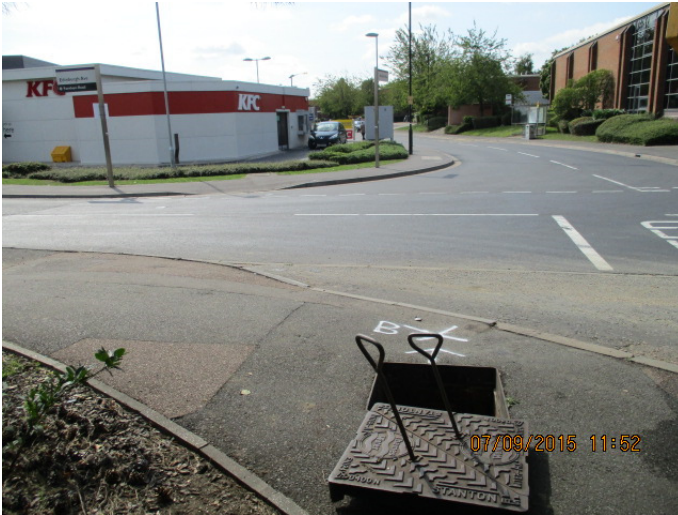
After the event it was found that a 300mm storm overflow pipe connected to the high level sewer had collapsed. The obstruction was probably caused by utility works that took place over the top of the pipe. Prior to the utility works taking place the 300mm storm over flow pipe was known to be clear and flowing freely.

Figure 2-4 SBC inspecting storm overflow on September 7th

Slough Borough Council has commissioned emergency works to return the storm overflow pipe to its original condition, the cost of which will be recharged to the company that caused the damage.

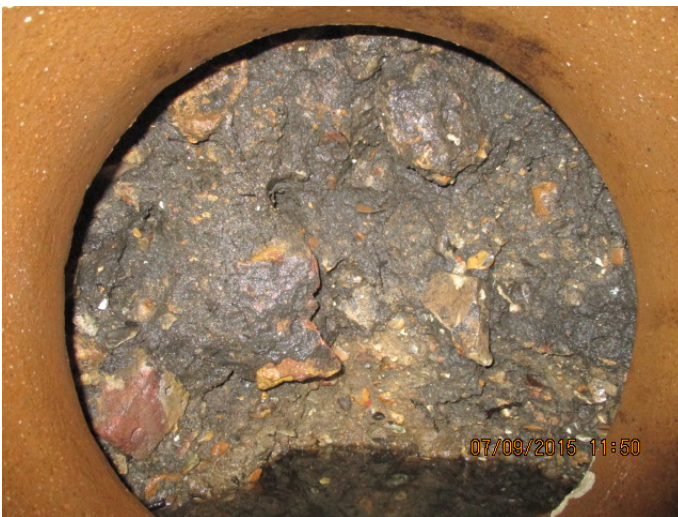
Figure 2-5 Blocked 300mm storm over flow pipe

If the 300mm storm overflow pipe had not been blocked storm flows would have been conveyed into the Salthill catchment quicker and the extent of flooding would have been reduced.

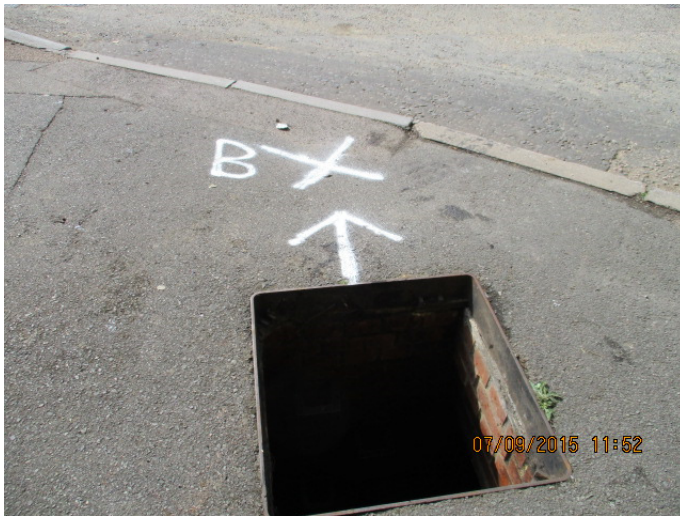
Figure 2-6 Location of blockage, indicated by the white cross (which follows the line of recent utility works)

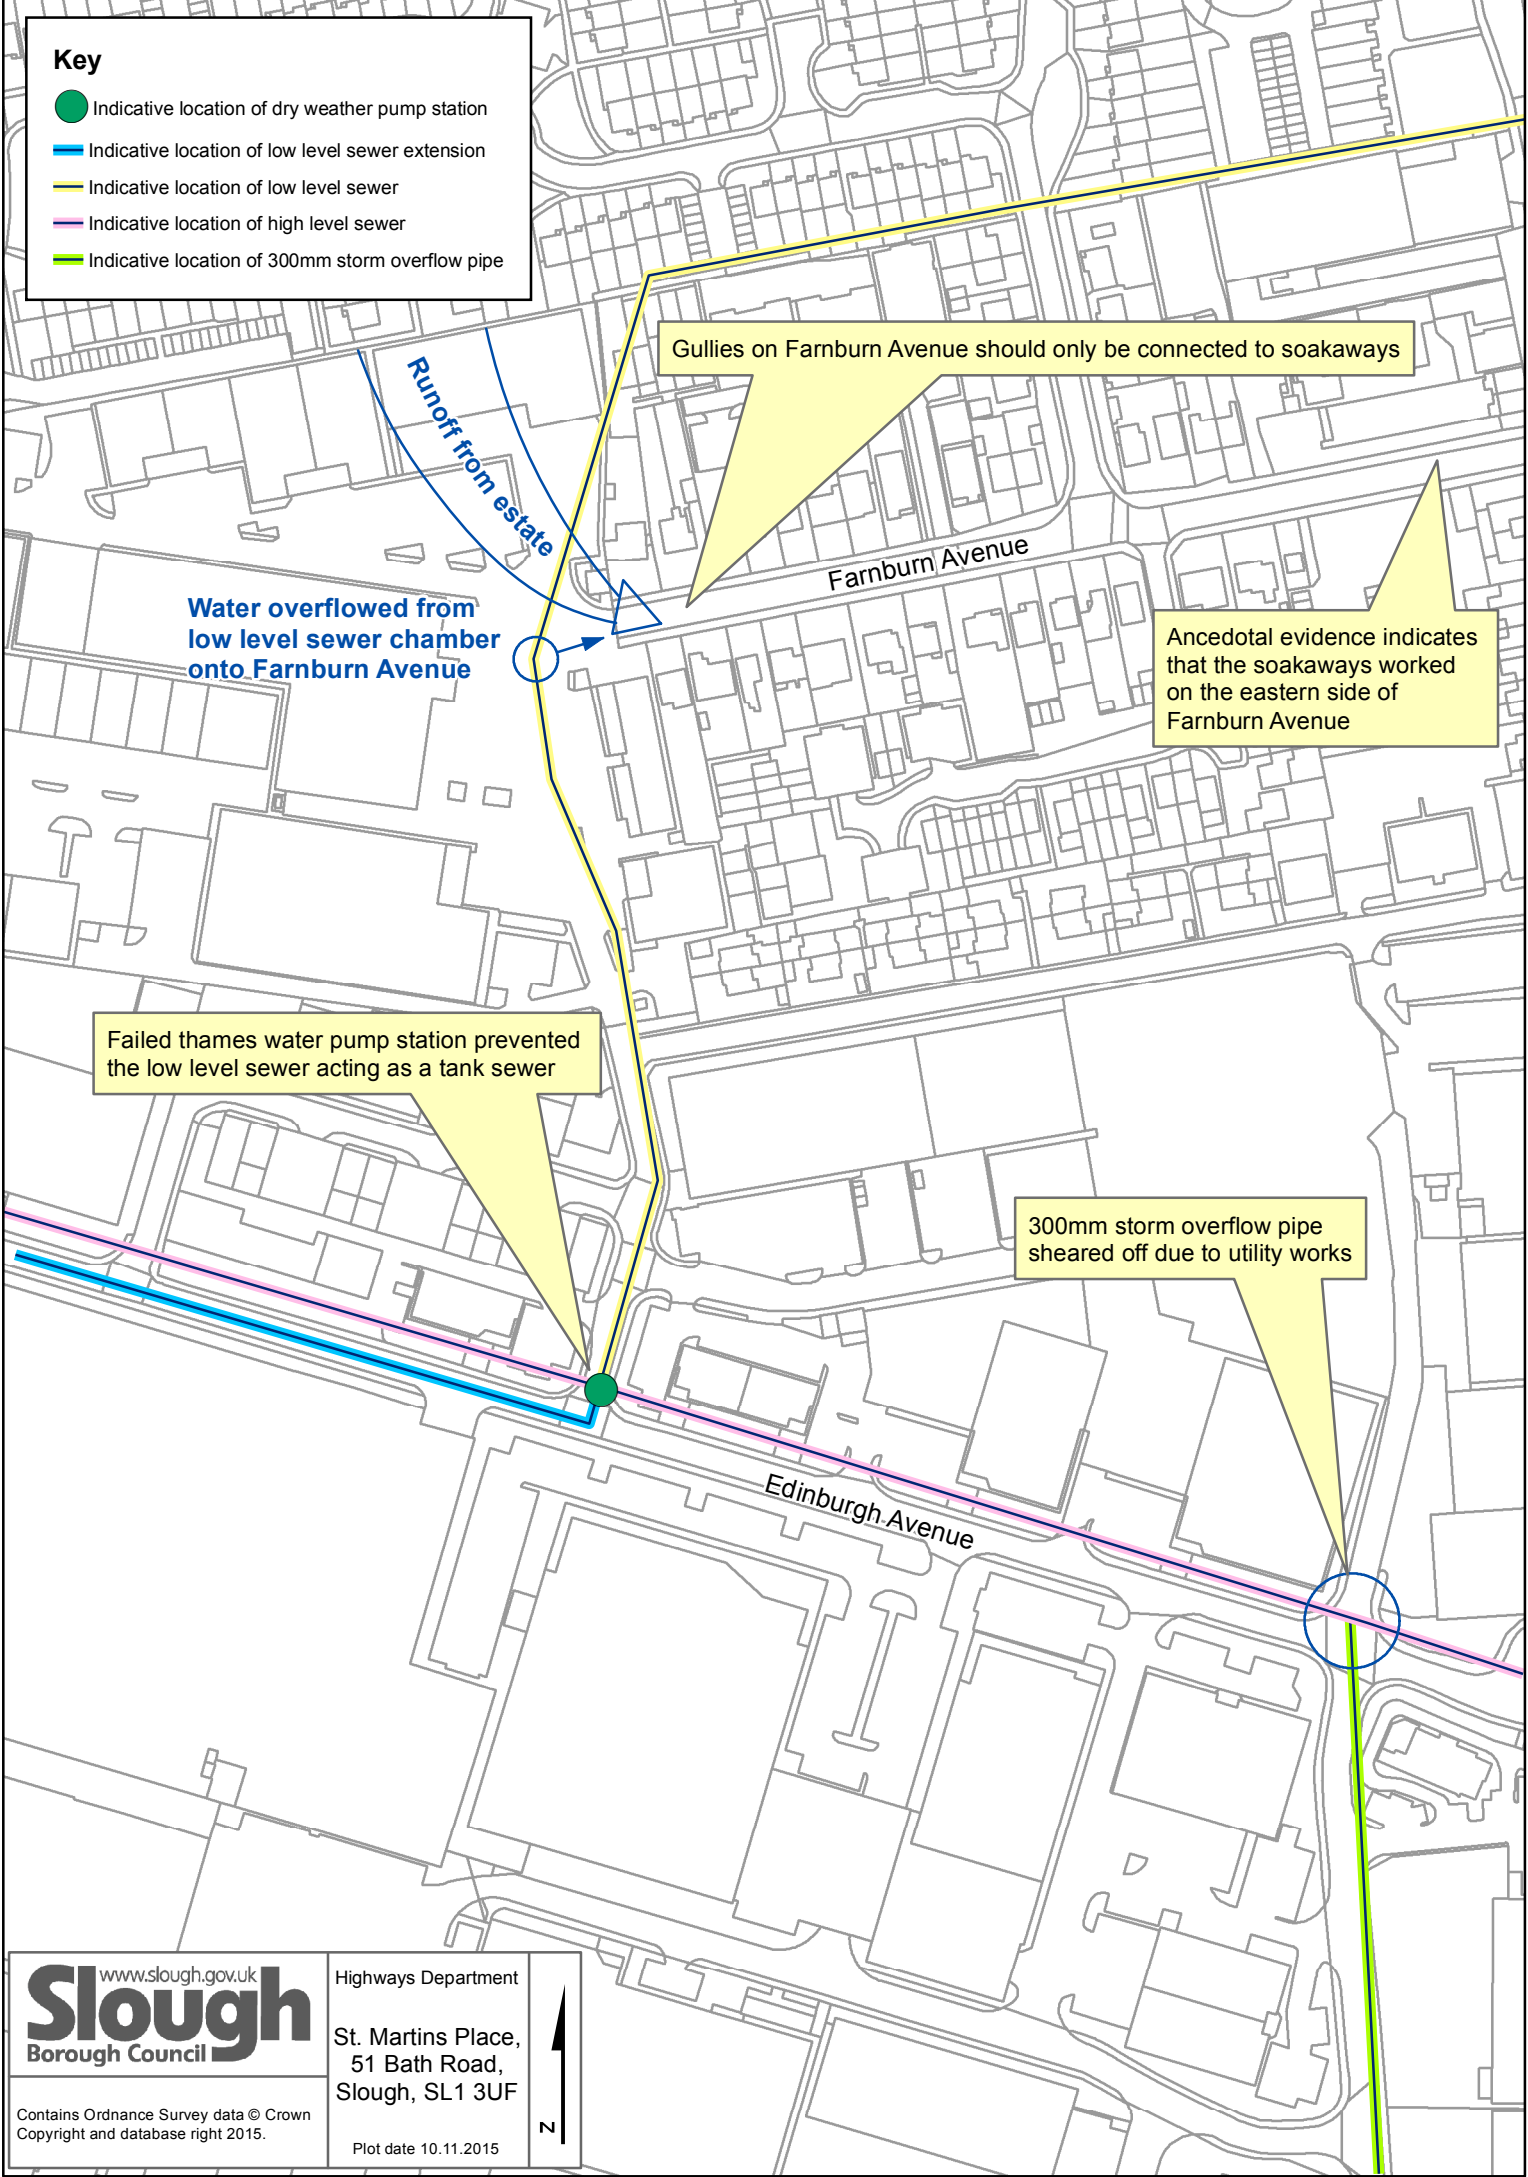
Appendix A. Figures

Runoff from estate

Water overflowed from low level sewer chamber onto Farnburn Avenue

Anecdotal evidence indicates that the soakaways worked on the eastern side of Farnburn Avenue

Failed thames water pump station prevented the low level sewer acting as a tank sewer

300mm storm overflow pipe sheared off due to utility works

Gullies on Farnburn Avenue should only be connected to soakaways
