Section 19 Flood Investigation

Colnbrook Flooding - February 2014

Slough Borough Council

March 2015 v1.0

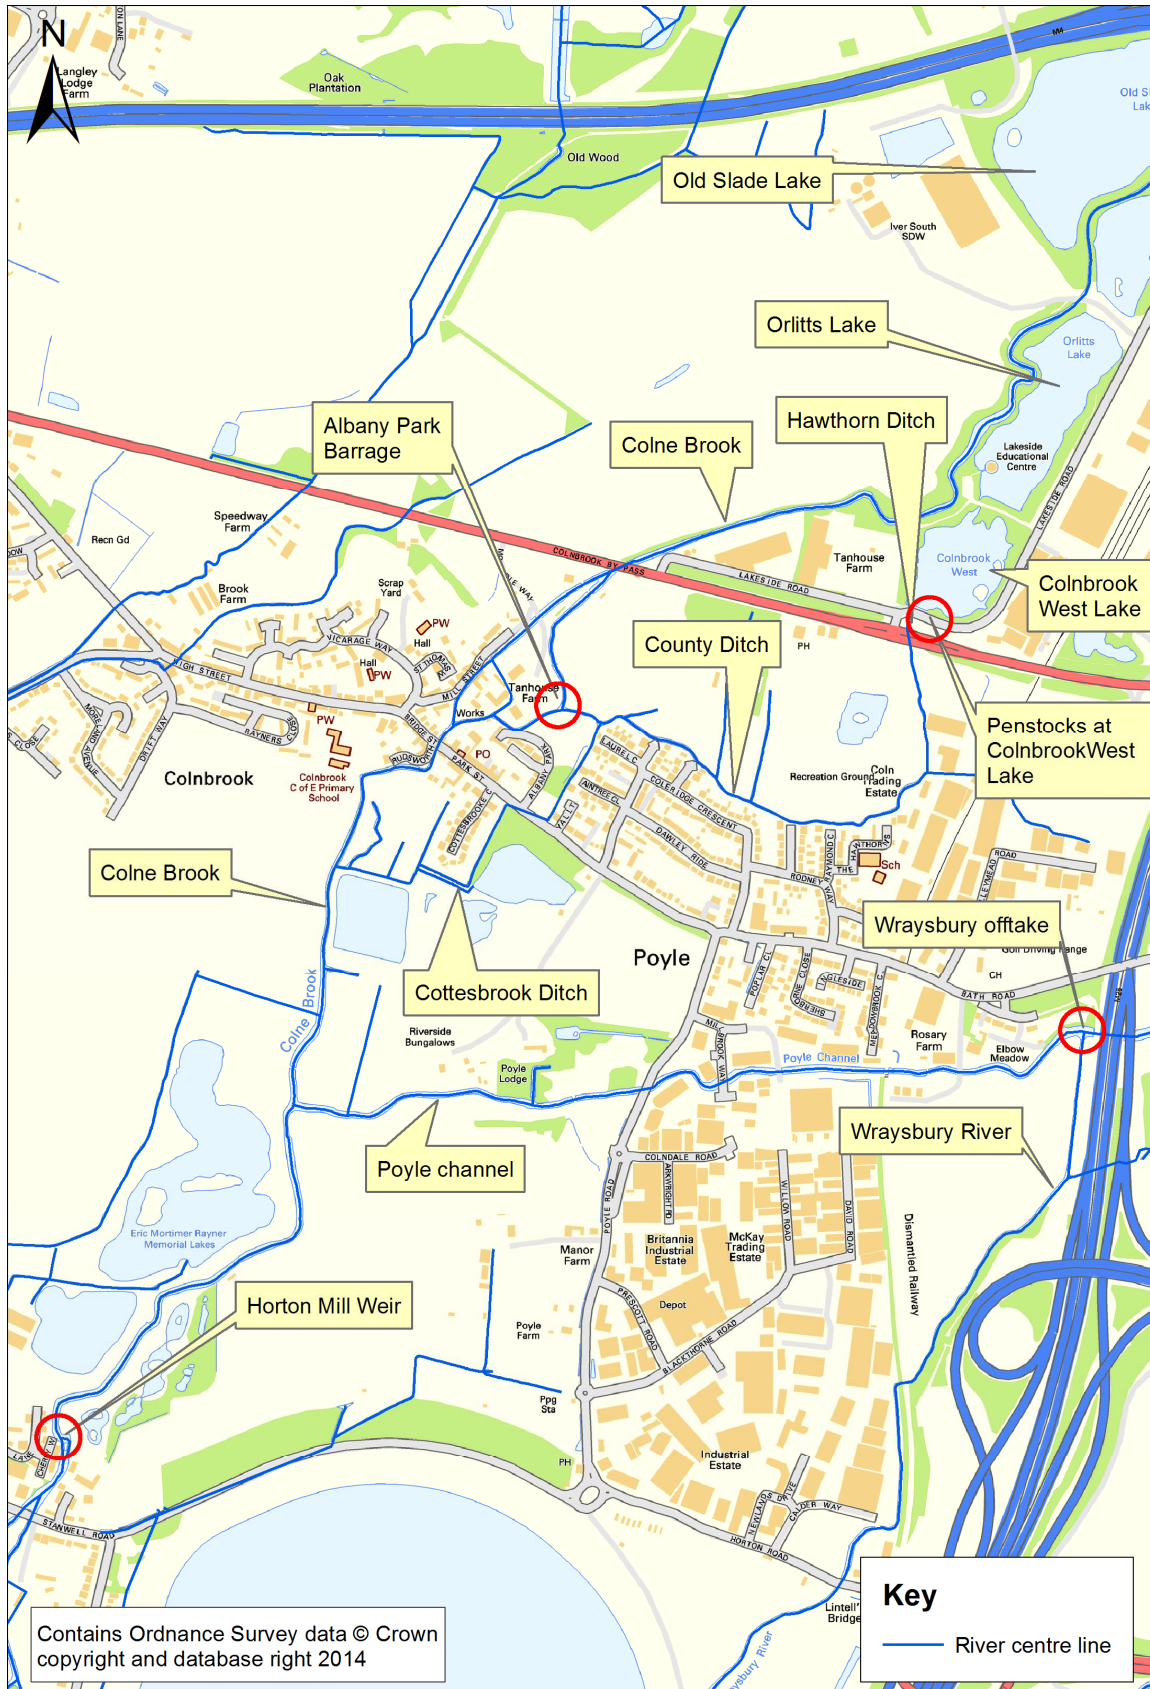
Figure 2-1 Investigation area and key features

This Section 19 investigation covers flooding occurring in Colnbrook and the surrounding area that suffered from flooding between January and February 2014. Figure 2-1 shows the investigation area and key features.

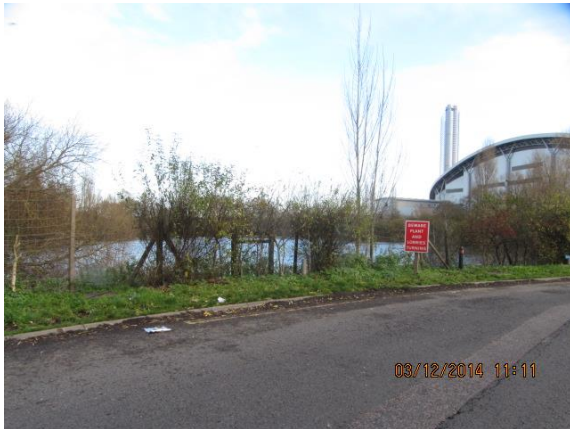
Colnbrook West Lake penstocks

Fluvial flood levels in the County Ditch should be controlled by the 2005 flood alleviation scheme, which was designed to cope with rainfall falling over the Colnbrook catchment only. To achieve this, flow should not be allowed to enter County Ditch from the Colne Brook during flood conditions. This is achieved by closing the 3 penstocks on Colnbrook West Lake. In doing so the flow into County Ditch is reduced to the rainfall falling in the catchment and any groundwater baseflow.

At the time of the flood event there was some uncertainty over which risk management authority should operate the asset. Since then Slough Borough Council and the Environment Agency have worked together to establish temporary operating conditions for all 3 penstocks on Colnbrook West Lake. The main penstock is currently closed and the temporary operating is in procedure in place. Slough Borough Council are also investigating designating the asset and are also considering the needs of Boyer Fishing, who occasionally need to operate the penstock to keep swims open for fishing. This type of operation is safe to do so if correctly managed and protocols are put in place to facilitate this.

Moving forward the temporary protocol will be kept in place and monitored. Slough Borough Council does not have the authority to operate the main penstock on a day to day basis, and the Environment Agency will not manage the operation on a day to day basis either. The 2 other penstocks (HW1 and HW3) will be controlled by Slough Borough Council to stop backflow from the lake travelling to the road. Slough Borough

Council will achieve this by fitting a flap valve in the catchpit upstream of the outfalls (See Appendix A). Note neither Slough Borough Council or the Environment Agency owns the West Lake penstocks or the oil interceptors. It is assumed that they are owned by Goodmans, who is the current land owner.

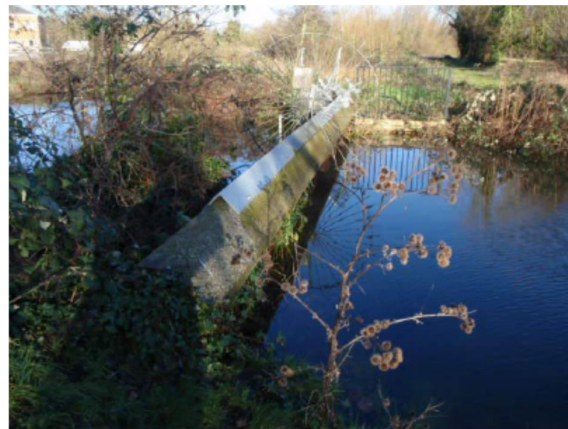
The Albany Park Barrage prevents backflow from the Colne Brook River into the County Ditch, while a new upgraded drainage channel allows flow to drain from the area through a culvert under Park Street / Bath Road.

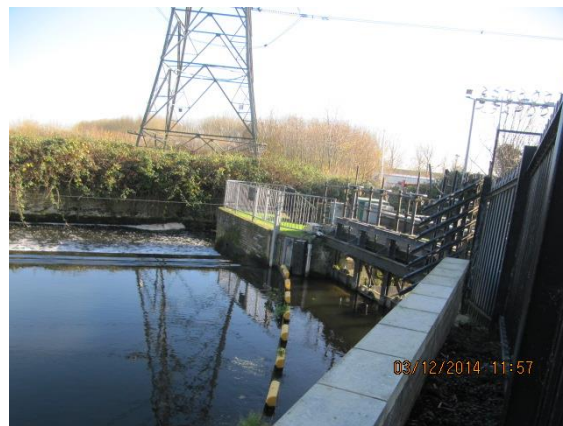
Horton Mill Weir and assets

Horton Mill Weir, consisting of the weir and 4 sluice gates, influences how water drains from the catchment. Horton Mill Weir is over 1.5km downstream from the Albany Park Barrage but the river slope is very shallow - land only falls by roughly a metre between the barrage and the weir. Due to this shallow slope, and during extreme conditions, it is possible that water levels in Colnbrook could be affected by the operation of Horton Weir and its assets.

- Meeting with the former operator of Horton Mill Weir . A meeting has been held with the former operator of Horton Mill Weir whose has a great deal of experience with the catchment and how it drains. He suggested changing the operating conditions of Horton Mill Weir assets which have been taken on board by the Environment Agency (the current weir operator). The suggestions have been actioned and will be monitored over the coming winters.

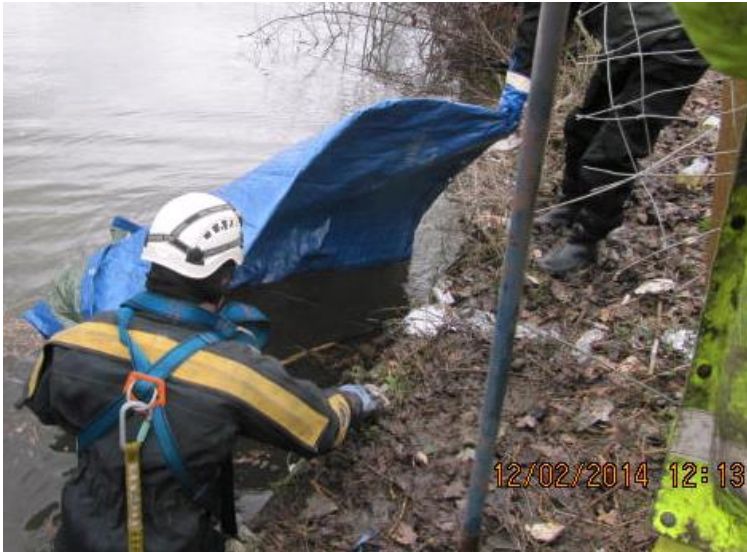
On the 11th of February Slough Borough Council checked the West Lake penstocks. The 2 penstocks (east) on highway drainage were noted to be fairly well closed (but managed to get a couple of extra turns in). Seatings were obstructed so needed sandbagging to restrict flow to a reasonable level. However the main penstock outlet to the lake was fully opened and completely submerged. The seating was badly obstructed and needed tarpaulin and bagging to obtain a reasonable reduction in flow. The penstocks were confirmed as being open on the 11th February and were sealed on the 12th February 2014 by Slough Borough Council. Residents noted that after the penstocks were closed water levels dropped significantly. This was confirmed by Environment Agency staff that visited Colnbrook Village on the 13th February and noted the observed levels to be lower than they were on previous days. Coincidentally water levels were also observed to drop dramatically over a short period of time in other regions of the River Colne Catchment over the same dates.

The Environment Agency have stated that they did not shut the penstock before the event so it is not known for how long the main penstock was open or why it was open. It was important for the main Colnbrook West Lake penstock to be closed off however it should also be noted that due to the large volume of water passing down the Colne Brook if the main penstock had been shut for the duration of the event water would have overtopped the West Lake embankment earlier and flood water still would have flowed towards Colnbrook.

SBC sealing the main penstock at Colnbrook West Lake.

Date	Actions taken
	<ul style="list-style-type: none"> • The main penstock at Colnbrook West Lake was located, shut and sealed with tarpaulin and bagging by Slough Borough Council staff entering deep water. • Call received from Highways advising water levels dramatically reduced in Colnbrook. Tall Trees almost clear; Albany Park maximum depth 6.5 inches; Aintree, Dawley; Coleridge Crescent now clear - Fawsley and Laurel - max depth 5 inches.
13th February	<ul style="list-style-type: none"> • Tanker sent to mop up isolated puddles. • Tree down on Mill Street . the Environment Agency were informed and advised it would be removed by lunchtime. • Continued offers of assistance from Businesses and the Community. • Decision made to shut incident room.
14th February	<ul style="list-style-type: none"> • Floods continued to recede. Residents who had their homes flooded and would like to get rid of flood damaged items were advised by Slough Borough Council to leave the items in their front gardens for collection.

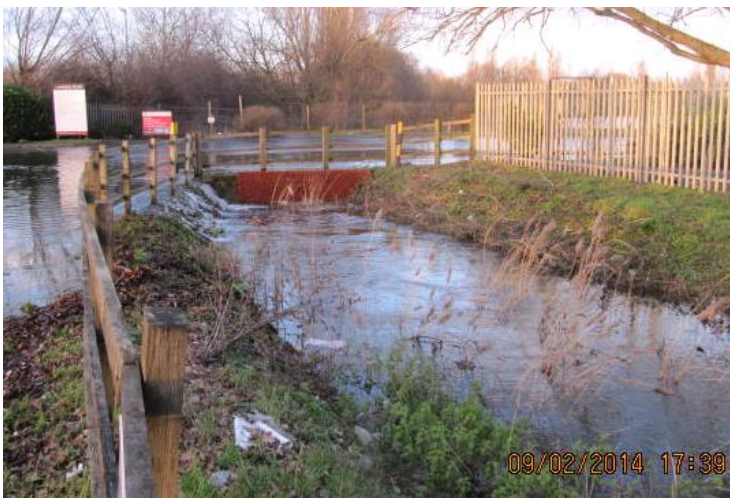
The managers of Colnbrook West Lake observed water spilling into the West Lakes from the Colne Brook but unconfirmed evidence suggests water could not flow back as anticipated. Trees and other debris were in the Colne Brook at various locations along the channel which might have created a sufficient head differential to prevent water from being able to pass back in. Instead of passing back into the Colne Brook water was forced over the downstream embankment of Colnbrook West Lake and down towards Colnbrook. Furthermore part of the crest of the embankment was built 9cm below the design level and so water was able to overtop sooner.

Water from West Lakes overtopping Lakeside road and draining into Hawthorn Ditch

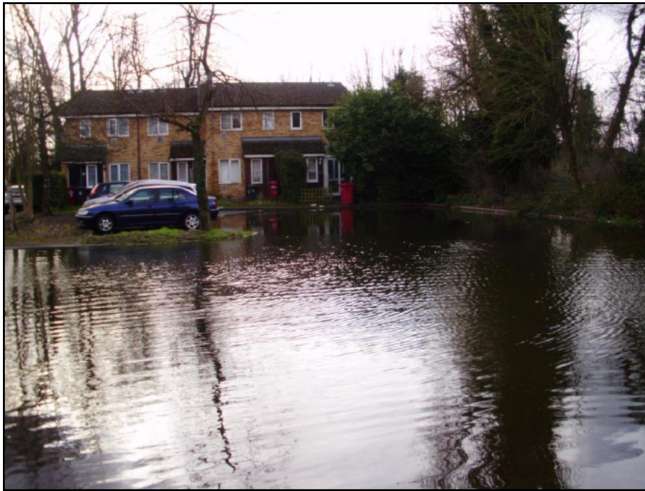
Residents commented that water came up through the floorboards on Laurel, Aintree, Fawsley and Myrtle Close. Residents also commented that water was flowing up from the surface water drains at Fawsley, Myrtle, and Laurel Close as well as at Tall Trees. The majority of the surface water drains are connected to soakaways but those closest to the watercourses are understood to discharge directly into the river.

Flooding in the car park at Tall Trees where residents noted water was coming out of the drain.

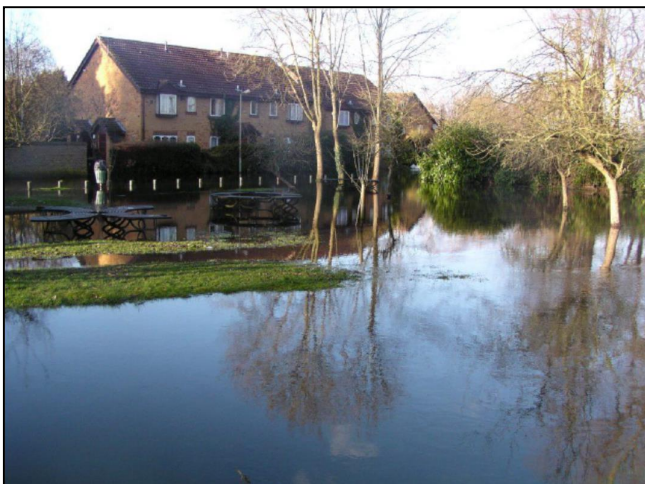
At Albany Park Environment Agency staff observed water flowing onto the road from the Park area on the 1st February suggesting that water was coming from the County Ditch (or Cottesbrook Ditch). This area is downstream from the West Lakes. Had the water in the West Lakes been able to pass back into the Colne Brook this area would probably have flooded to a lesser extent. Had the Colnbrook West Lake penstock been shut this area might also have flooded to a lesser extent. However if the West Lake penstock had been shut water would have overtopped the Colnbrook West Lake embankment sooner and flood waters would still have reached the area. Direct rainfall falling on drains full to capacity may have exacerbated the situation.

Flooding at Albany Park looking across the Albany Park space to the residential road.

On 1st February the Environment Agency looked for ways to alleviate the flooding in flood area 1. They checked for differentials in levels at the Albany Barrage and found 800mm freeboard downstream, which

suggested that there was capacity to pump over the barrage to draw down levels in Cottesbrook Ditch and the County Ditch. The pump arrived on 1st February and remained pumping for a number of days. Pumping at the barrage is an effective way to reduce the risk however the effectiveness can be improved by closing the Colnbrook West Lake penstocks.

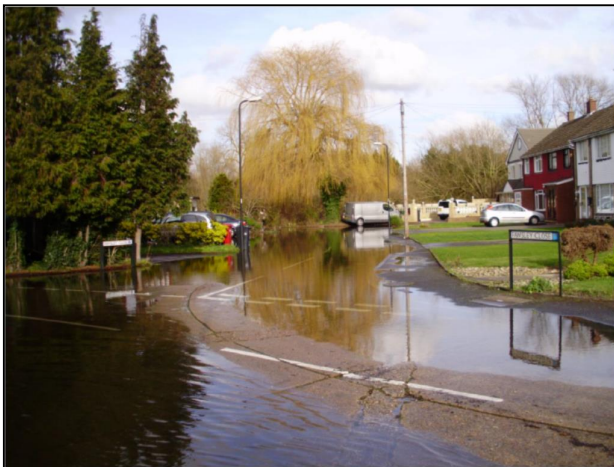
Observations at Bath Road culvert during the early part of the flood event (1st February) indicated that it was not flowing freely. This culvert is critical to draining flood area 1. At the time it was thought that the culvert was blocked so the Environment Agency used a pole to check for blockages and found none. The downstream culvert outlet was then checked to determine if there was any difference between the upstream and downstream levels. Although a slight difference was seen the Bath Road Culvert was assessed as not being blocked. This view is supported by the observed subsurface flow seen upstream. Instead slow flow through the culvert could have been caused by the backing up of water levels downstream. Since the flood, water levels have also been observed collecting at the culvert inlet. Investigation of the flow routine through this culvert should be undertaken to ensure water is able to flow freely during all flow conditions.

Flooding at Fawsley Close looking towards County Ditch.

SBC, EA	February 2015	Investigate Bath Road culvert flow routine Water appears to back through the culvert. The cause of this backing up should be investigated to check if the flow routine can be improved for all flow conditions.	N
SBC, EA	February 2015	Add fluvial gauge upstream of Orlitts Lake Add a gauge to improve understanding of the catchments reaction to inflows and to provide better flood warnings upstream of Orlitts Lake. This gauge will also help to inform the main West Lake penstock movements.	N
EA, SBC	February 2015	Update Colnbrook groundwater gauge to log daily or sub-daily levels The Environment Agency do not provide warnings for groundwater, however updating the gauge to log daily or sub-daily levels would provide a better understand groundwater movements and could provide a flood warning function. This gauge will also help to inform the main Colnbrook West Lake penstock movements.	N

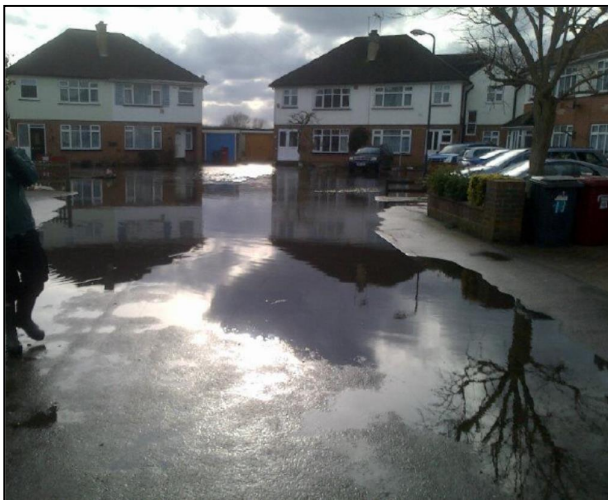
Cottesbrook Close was visited by the Environment Agency on 1st February 2014. Several gardens and roads were noted as being under water. A number of residents described water coming up from the floorboards, suggesting that the source of flooding was again from groundwater. Sewers were being tankered at the end of the Close to relieve pressure on the Thames Water pumping station further downstream however this had been a problem before the peak of the flood event.

Flooding at Cottesbrook Close looking southwards. Photo taken at about 13:30 on February 4th 2014

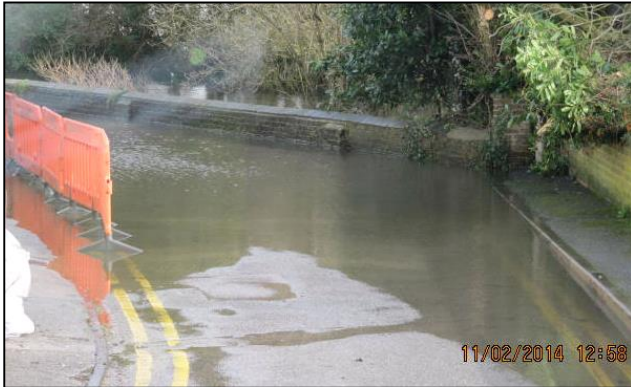
Flow was reported to be in bank at Mill Street on the 1st February 2014 apart from a section of road that flooded because a small defect hole in the raised brickwork channel wall allowed water in. River levels were reported to be high in the Colne Brook River. However during the duration of the event no internal flooding was reported. After the event 1 property reported flooding as a result of groundwater. As the event intensified the flood envelope along Mill Street broadened, but no properties reported fluvial flooding and the flood waters eventually subsided. Mill Street is deemed to have flooded from flow from the Colne Brook River. Groundwater levels in flood area 3 were high and 1 property reported flooding of this nature. However it should be remembered that river levels and groundwater levels near to the river are strongly connected.

Flooding on Mill Street
